A Review of Fundamental Shaft Failure Analysis

Abstract - This review paper gives the insights of various analysis carried out to find shaft failure. Roller Shaft failures can be optimized by preventive mechanical maintenance techniques & using safe design with proper manufacturing processes. The various literature has been systematically compared and reviewed to get a proper shaft failure analysis. Every method has its pros and cons and used by specific industrial segments. Shaft failure causes the unnecessary shutdowns and leads to heavy production loss. The objective of this paper is to study various shafts failure analysis and select the best method to find out the root cause failure of heavy nip roller shaft used in textile industry.

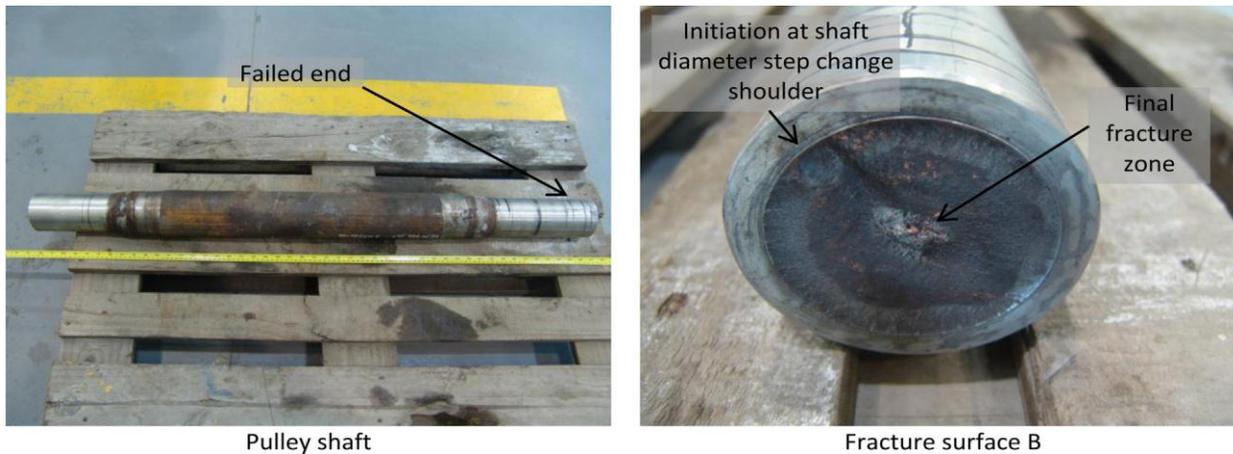
The macroscopic analysis of the shaft showed that the failure is of fatigue however closer microscopic examination revealed a fracture appearance that was more brittle and inter-granular than normal for a fatigue failure. The unexpected appearance of the fatigue fracture surface may simply be the characteristic of material. Comparing the fracture with fatigue test samples concluded the failure mechanism was fatigue.

Finite Element Analysis showed the stress report for various levels developed in shaft and obtained a graph of stress rang(MPa) Vs. fillet radius at shaft corner(mm).It concludes that the pulley shaft has failed due to fatigue mechanism and was a result of improper overhaul. A sharp fillet at the shoulder of shaft where the diameter of changes drastically. Welding carried out during shutdown resulted hardness change at fillet shaft shoulder. The manufactured mechanical parameters stood at their ground and do not intervene in failure however improper service contributed majorly to shaft failure.

Fig-1: Failed pulley shaft [1]

Sr no.	Author	Failure reason	Research tool	Year
1.	Gys Van Zyl, Abdulmohs in Al-Sahli	Shaft failed as a result of fatigue.	chemical composition by means of XRF, SEM analysis, Finite element analysis using ANSYS	2013

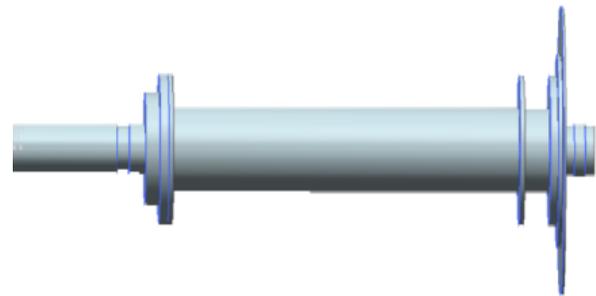
The Material of content of shaft was found to be standard. Average micro hardness, yield strength & tensile strength were 157 HV, 349 MPa, 527 MPa hence the material quality was good and failure was not due to material property. FEA showed the remarkable stress concentration at the shoulder's chamfer 5mm, but the actual radius was 2mm. The higher stress concentration and torsional vibration induced the micro crack's initiation along the chamfer and grew in size due to continuous stress and torsional vibration.

Fig-2: The three-dimensional model of induced draft fan's shaft. [2]

2.	Jinfeng du Jun Liang Lei zhang	Actual radius of chamfer less than the design radius caused more significant stress Concentration.	Fractography Using SEM, Spectroscopy, Finite element analysis using ANSYS	2016

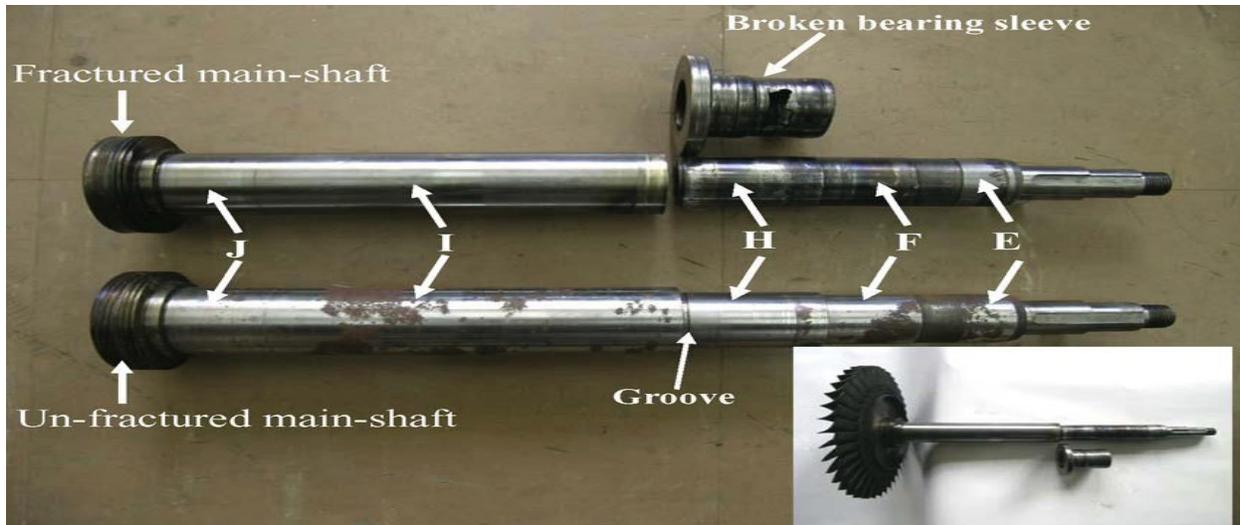
This paper is an analysis of failure of main shaft of locomotive turbo charger. The fracture position is located at a groove between journals with different diameter. The rotating bending fatigue is the dominant failure mechanism of the shafts. Detailed metallurgical analysis indicates that fillet region of the groove had subjected to high temperature. This resulted from the intense friction between the bearing-sleeve and the assisted pushing Bearing, which made the fatigue strength of the fillet region of the groove decrease.

It was worth noting that too short fillet radius increased the stress concentration so high that it facilitated the fatigue cracks to initiate in the fillet region of the groove. It further facilitated the conditions responsible for the rotation-bending fatigue fracture of main-shaft.

Fig-3: Fractured main-shaft and broke bearing sleeve. [3]

3.	Xu Xiaolei , Yu Zhiwei	wear of the bearing sleeve	Fractography,Spectroscopy	2009
4.	A.M. Lancha, M. Serrano, J. Lapena, D. Gomez Briceno	Improper thermal treatment of the material	Fractography using SEM, EDS, Charpy tests	2001

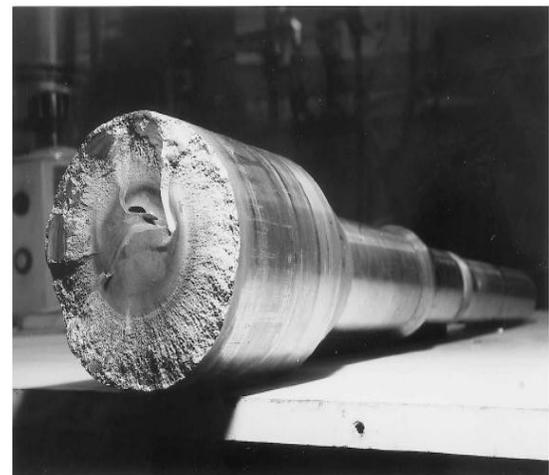
This paper analyses the failure of a river water circulating motor shaft. It includes Fractography, Metallography & Energy dispersive spectroscopy. It also focuses on the various mechanical tests to find out root cause of the failure. Location of the failure surface was not on any fillet, corner or keyway but at 600mm from of the ends of the shaft. Shaft failed after 80,000 operational hours. The characteristics of the fatigue are neatly mentioned. The Fractography was determined by the scanning electron microscopy. It stated that cracks are of inter granular morphology with grains.

Fig- 4: Photographs of the failed shaft [4]

embrittlement, Temper and Hydrogen Embrittlement. The shaft showed cracks internally first and then on the surface. It was concluded that the shaft failed due to improper thermal treatment. It facilitated temper embrittlement process.

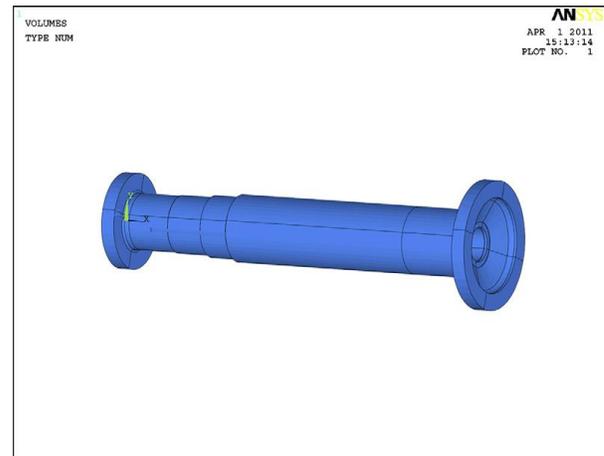
The finite element model of the shaft showed more stress concentration than at critical radius than the limiting values. It was concluded that shaft failed due to the combination of several factor:

Fig- 5: 3D shaft model [5]

5.	Tomaz Vuherer, Zoran Odanovic, Ivana Atanasovska, Dejan Momcilovic, Radivoje Mitrovic	Inappropriate corrosion protection in the zone of critical radius	Spectroscopy, Finite element analysis using ANSYS, Charpy tests	2012

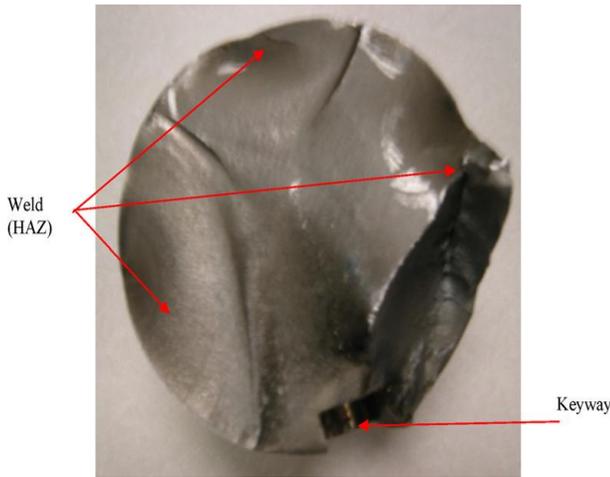
The shaft was a loose fit hence it was installed using weld plugs of AISI304SS. In transmission system it was uncertain whether the gear box was pivoted, the gear box did not influence shaft failure. Also, the torque arm was not under any preload. The key way material was same as that of shaft and 12.7 mm². During chemical analysis spectrometer readings were taken and the material AISI304SS. This material is susceptible to sensitization during welding process.

Fig-6: Failed shaft with heat affected zone (HAZ) and keyway. [6]

The microstructure shows that the grains were distributed unevenly along the entire austenite matrix, the face is referred to as delta ferrite stringers. This facilitates blocking of inter granular cracks. However, if temperature during welding reaches high value, it becomes sensitized and lose this properties. Electron microscope shows that inter granular cracks were centered at the weld location. Further calculation reveled that stress concentration at the weld plugs was higher than the standard design. The fillet corner was too sharp to withstand the stress concentration for longer duration. At percent speed 99 safety factor with stress concentration was 1.001. The failures causes were more allied to welds. Because of vibration issue of loosely fit shaft weld plugs were used which resulted in stress concentration.

6.	R.W. Fuller, J.Q. Ehr Gott Jr., W.F. Heard, S.D. Robert, R.D. Stinson, K. Solanki, M.F. Horstemeyer	Failure of shaft occurred due to improper welding	Fractography using SEM, spectrometer	2008

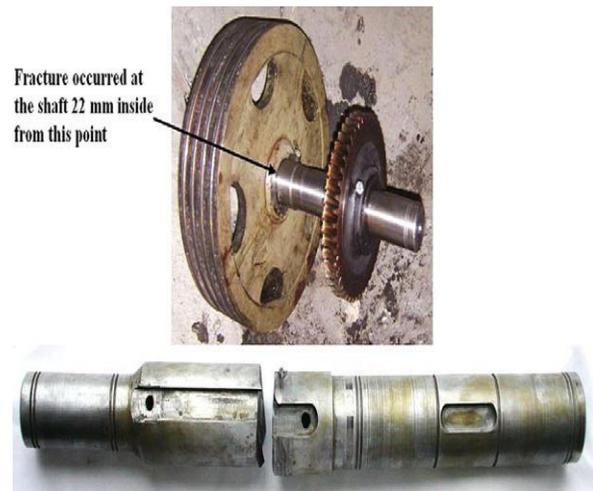
During the stress analysis, minimum and maximum shear stresses are investigated at the fracture surface. Total shear stress was found to be 25.7 MPa. Visual examination concluded that the surface from the keyway ground to the keyway side surface was approximately perpendicular hence radius of curvature was negligible.

Fig- 7: Failed elevator drive shaft. [7]

By taking the shaft geometry into consideration notch effect is calculated. By determining the Endurance Limit and Equivalent stress, Fatigue Safety of Factor is achieved to be 1.05 which is quite low. It was concluded that by increasing the radius of the curvature of keyway the stress could be diminished at high value. By using the FEM stress intensity and concentration are shown.
