A Review on Repair and Rehabilitation of Heritage Buildings

Abstract - Information regarding this paper discusses the Review of Repair and Rehabilitation of Heritage Buildings. In current scenario of Building Research, Repair and Rehabilitation plays a vital role as it serves important in building applications. It acts as an inevitable solution in maintaining the Integrity of Structures, in case of Heritage structures. Repair and Rehabilitation of heritage buildings has become a concern of greater importance over the world, notably in the developed countries. The major defects reported are discussed and a suitable and economical solution for a particular defect is identified by a tradeoff between cost, lifetime and adaptability of the solution.

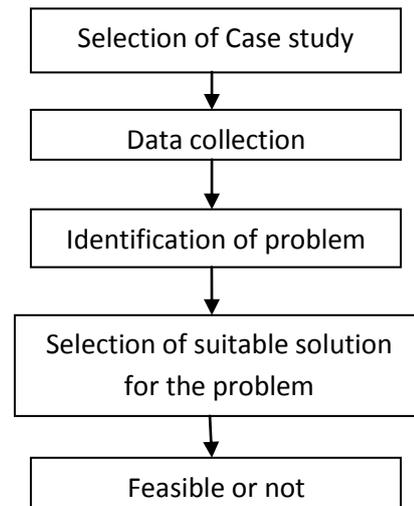
Flowchart-1: Process of Repair and Rehabilitation

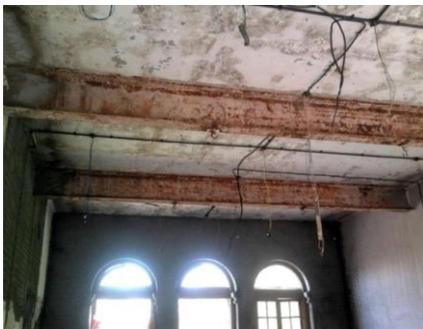
Fig-1: Roof leakages [1]

Sayali Sandbhor, et al proposed their Repair and Rehabilitation work on a building, which was constructed during British period in the year 1871. The author identified various problems such as structural cracks in masonry walls, crack in lime concrete slab, collapse of column portion and roof leakages. These are caused due to poor load distribution, poor waterproofing, seepage of water and water logging [1].

Sayali Sandbhor, et al suggested several suitable solutions for the above said problems. Epoxy grouting is used for strengthening of weakened and cracked masonry walls. Jacketing of wall surfaces was made by applying mesh nonferrous steel reinforcements and by filling the gaps with lime mortar. Cracks in lime concrete slab were fixed by welding of steel members. Collapse of column portion was restored by removing the collapsed portion and reconstructing the portion was carried out using same type of stone and mortar. Roof leakages were restored by providing proper slopes and by replacing the corroded members using Lead flashing. [1]

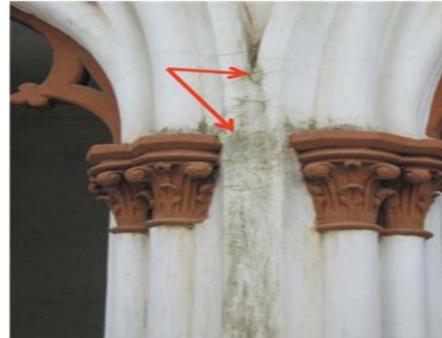
Fig-2: Arrows indicating Mold stains [2]

Secondly, C.Natarajan, et al reports the Rehabilitation of St. Lourdes Church, Tiruchirapalli which was built in the year 1890. The author faced various problems such as mold stains and water damage, cracks in the outer brick surface and decay of bricks in the inner surface and erosion on the roof surface. These are also caused due to poor waterproofing, seepage of water and water logging [2].

Secondly, C.Natarajan et al advised several solutions for the above said problems such as follows. Soap water under pressure was applied to clean out the surface of mold stains. Cracks in the outer brick surface and decay of bricks on the inner side were repaired by replacing cracked and decayed bricks. Lime mortar grouted along the surface was used to recover erosion of roof surface. [2]

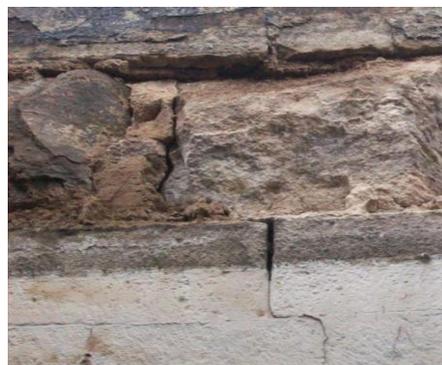
Fig-3: Vertical cracks and gaps [1]

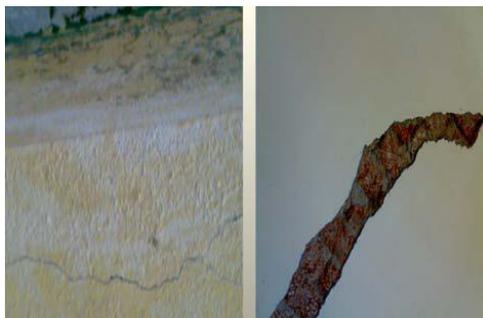
Fig-4: Cracks in ceilings and walls [3]

identified several problems such as spalled plaster, fungus growth in walls, cracks in the ceiling and masonry walls, corrosion and spalling of concrete in columns. These are mainly caused by severe water leakages and environmental distress [3].

Furthermore, Suresh Chandra Pattanaik, et al advocates various solutions for the said problems. Repair of cracks in walls were cured by chipping of plaster and cutting of V grooves along the length of the crack by Chiseling, the cleaning was made by a high pressure water jet. Wire mesh was fixed along the cracks after which the cracks were repaired with medium structural grade repair mortar. Strengthening of masonry column was implemented by providing Steel Jacketing which is braced with tie rod in a zigzag way. [3]

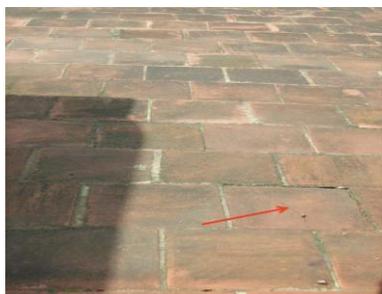
Fig-5: Cracks at roof surface [4]

Gaby Ruiz Petrozzi, et al in 1917 The authors proposed their Rehabilitation work on a 100 year old adobe church named Santisma Cruz Del Norte, located at the center of metropolitan Piura, built in the year 1917. The authors encountered several issues such as cracks at the corners of the walls and across the back wall, cracks between an RC choir loft and the adobe walls, eroded blocks and cracks at roof level. These were mainly caused due to moisture seepage [4].

Followed by Suresh Chandra Pattanaik, Gaby Ruiz Petrozzi, et al propounded several solutions for the said problems. To control wall cracks, strips of galvanized welded-wire fabric were used and they have been tied against the walls. To improve the stability of adobe walls, knee braces were used in the adobe walls and are tied up in the roof truss [4].
