# Experimental Evaluation of strength of Damaged RCC Beam Repaired using Steel Mesh at 45° and Modified mortar

Sachin Raveendran <sup>1</sup>, Dr. Sreemahadevan Pillai<sup>2</sup>

<sup>1</sup>PG Student, Department of Civil Engineering, NSS College of Engineering, Palakkad, Kerala, India

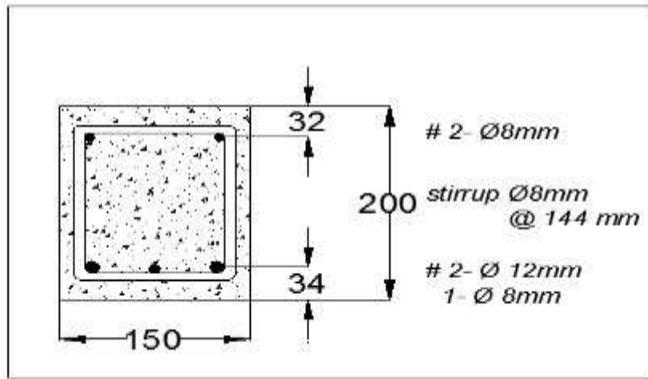
Fig-1 Details of Control Beams (CB)

The 4 control beams and 4 modeled damaged beams specimens of size 2000 x 200 x 150mm and were casted.

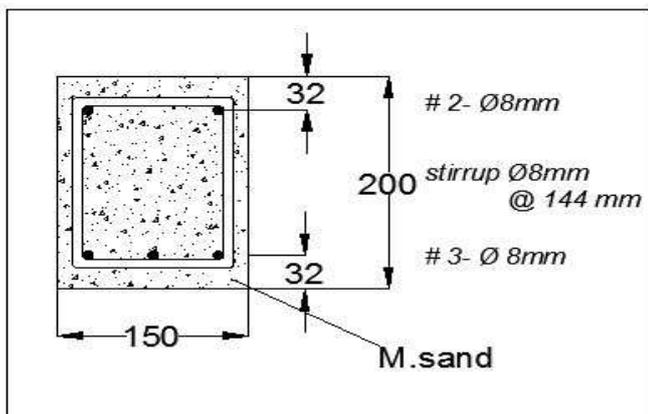
Fig-2 Details of Control Beams (CBRA)

For the control beam with reduced area of tension reinforcement (CBRA) 3 numbers of 8 mm diameter were

provided at tension zone and 2 hanger bars of 8 mm diameter were provided at compression zone as reinforcement.

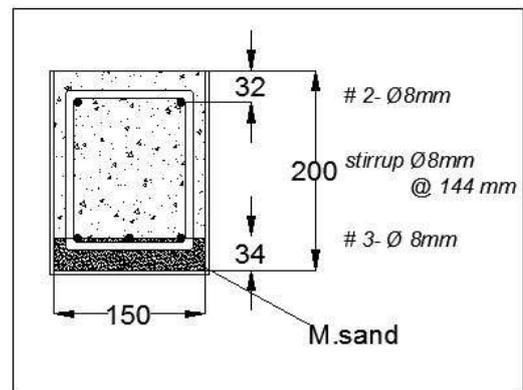
Fig -3 Details of Damaged Beam

For the modeled damage beams (MDB) 3 numbers of 8 mm diameter were provided at tension zone and 2 hanger bars of 8 mm diameter were provided at compression zone as reinforcement

Spalling of cover concrete was modeled by keeping sand filled up to the level of tension reinforcements in beam mould for its full length, before concreting. After 28 days of curing, beams without cover concrete were taken out. The exposed reinforcements were cleaned with wire brush, the surface of substrate concrete cleaned by

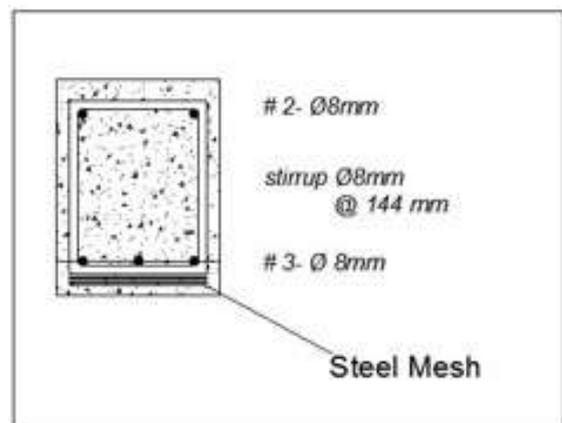
Fig -4 Details of Repaired Damaged Beam

Among the 4 damaged modelled beams 2 were repaired using steel mesh at 45° and repaired using steel mesh at 90°. After the curing period, the interface surface is thoroughly cleaned using a wire brush and sand paper to remove sand and other loose particles. The surface is made as dry as possible. Steel pieces having 5mm height were welded vertically above each stirrup as shear keys. Bonding agent two-part-epoxy coating is applied at the interface using a brush. modified concrete is prepared

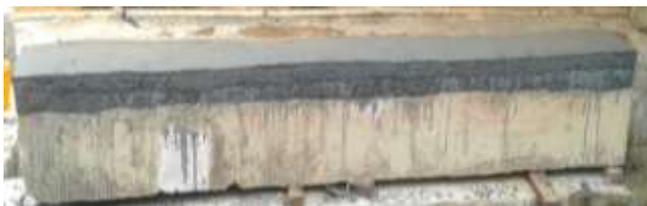
Fig -7 Repaired Damaged Beam

Then the 5 layer of GI mesh tied to the reinforcing bars after which the repair concrete is applied at the top. In between each layer 110 mm length steel pieces are provided in transverse direction to maintain uniform spacing. The finished depth of repaired beam is 250 mm. Kept for curing for 28 days by immersing in water.

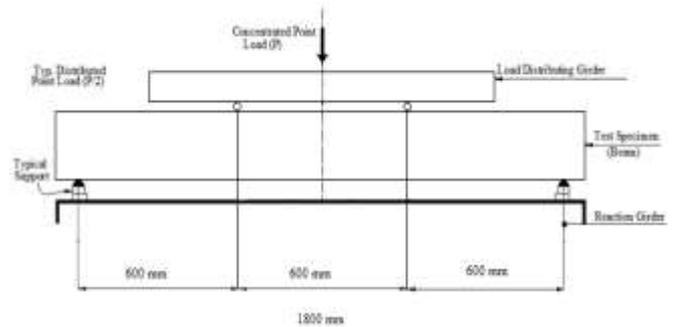
Fig -8 experimental setup

Two steel columns were erected over a girder placed on rigid footing. The column head placed with an arrangement on one side is roller and another side as hinge with two plates and a pin at the centre. The beam was placed on those supports with exactly 1800 mm distance from the centre of roller to centre of pin. At 1/3 points two round rods of 10mm were placed over them a steel girder was placed. Exactly at the centre between two round rods on the girder a hydraulic jack was placed. The top of the hydraulic jack was fixed with a proving ring with dial gauge of capacity of 100 KN. The arrangement

facilitates to transfer reactive loading from jack exactly at 1/3 of span as point loads

The present study concentrates on evaluating the efficiency of full length repair on beams with spalled cover to reinforcement. The beam was loaded under two point loading in order to keep the BM constant and predominating at the middle one third region. Further, shear force is zero due to applied loads in this region except shear due to self-weight exists. The zones near supports with 1/3 span length will have predominating shear with less influence of flexure. So the pure flexure behaviour can be studied.

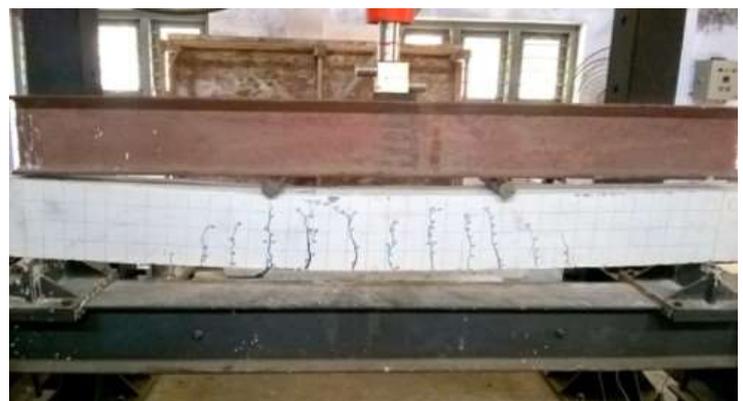
Fig -9 Crack pattern of Control Beam- CB

Vertical flexural cracks were first observed in the middle portion of the beam at 25kN and the beam failed at 60 kN in flexure. The deflection on one side is found to be slightly higher than that of other side i.e. at dial gauge positions 1 and 3, and maximum deflection was observed at mid-point i.e. at dial gauge position 2 as expected.

The flexural cracks were evenly distributed in the pure bending zone. Flexural cracks were found to be started from bottom of the beam and extended near to the top almost vertically. Flexural-Shear cracks were visible in the shear affected areas (middle thirds near supports). Flexural-Shear cracks also started from the bottom vertically but turned to diagonal directions near shifted neutral axis. Beam failed by crushing of concrete in compression after yielding of tension reinforcement as expected for under reinforced flexural failure.

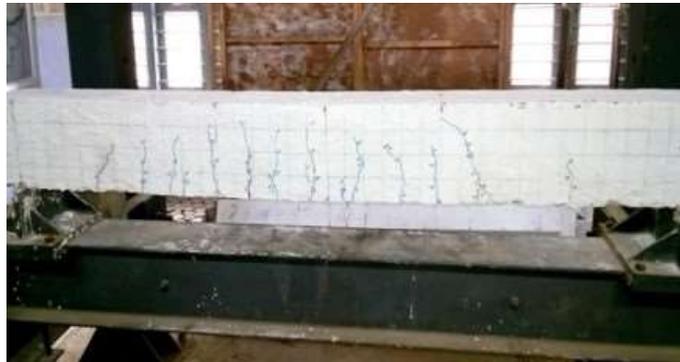
**Fig-10** Crack pattern of Control Beam with Reduced Area reinforcement- CBRA

as 38 kN with P = 18.83kN. The control beam with reduced area of tension reinforcement started showing visible cracks at 15kN and failed at 50 kN though the expected value was 38 kN. We had reduced the area of tension steel in this beam compared to original control beam by 45% to simulate loss due to corrosion.

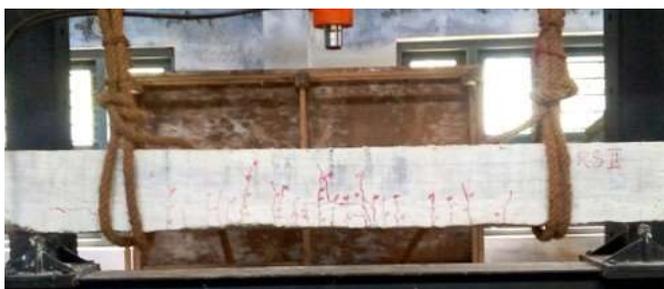
**Fig -11** Crack pattern of Repaired Beam (RB @ 45)

Both repaired beams (RB1 &RB2) using steel mesh vertical cracking were observed to start at a load of 25kN. In RB1 flexural and shear cracking were well developed by the load reaching 60 kN and the beam failed at 75 kN load and RB2 failed at 70 kN load. The repaired cover concrete did not spall off till the full strength of beam was developed. This shows the adequacy of repair. The failure load is greater than that of control beam showing complete successful repair.

The crack patterns repair modeled beams were seen to be same as that of control beam specimen. flexural cracks were evenly distributed in the pure bending zone. Flexural cracks were found to be started from bottom of the beam and extended near to the top almost vertically. Flexural-Shear cracks were visible in the shear affected areas (middle thirds near supports). Flexural-Shear cracks also started from the bottom vertically but turned to diagonal directions near shifted neutral axis. Beam failed by crushing of concrete in compression after yielding of tension reinforcement

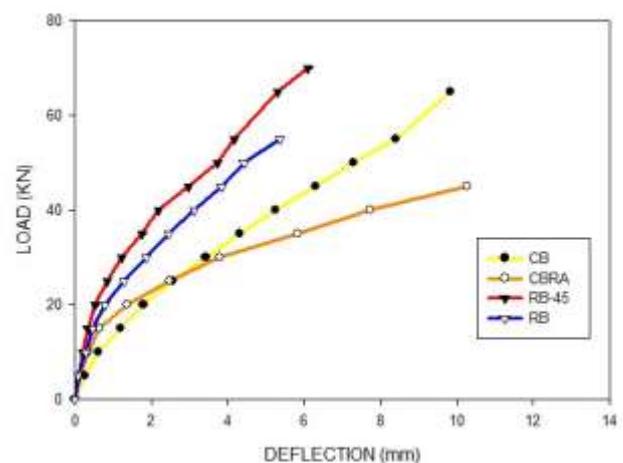
**Fig-129** Load Vs Deflection Graph of Control Beams and Damage Modeled Beam with Steel mesh oriented at 45° and 90°

All the results are analyzed on the basis of performance of control beam C12. The control beam C8 is with reduced area tension steel; hence very under reinforced and hence failed at a lower load with large deflection. The repaired beam with geogrids could attain

comparable load carrying capacities against their control beam. Beam repaired with geogrids showed strength similar to control beam c12 showing their ability to compensate for reinforcement lost by corrosion. But they could not provide additional flexural strengths. Beams repaired with steel mesh at 45° and modified mortar showed excess strength than control beams and shows better ductility in failure than beam repaired with steel mesh at 90°. Hence spalling repair using epoxy, steel mesh at 45° and modified mortar can be proposed as an effective method. All the beams have shown crack patterns displaying the integrity of structural action without failures other than flexure; ie shear, pullout etc.
