INFRARED THERMOGRAPHY AND ITS APPLICATION IN BUILDING CONSTRUCTION

Snehal R. Khedkar¹, Prof V.R. Dhawale²

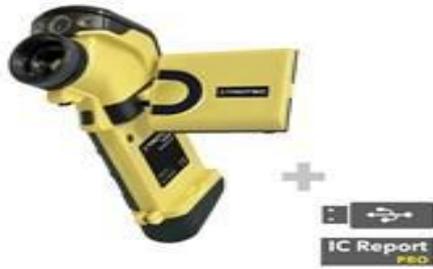
Fig -1: A typical infrared camera

The cameras are often application specific: cameras for application on structure have lower ranges and precision than those for electrical equipment (motors and transformers). Sources of radiation on the body should be shielded from the object for valid result. It is advisable not to take thermal images in bright sun or when the body is exposed to radiation from any sources to heat (glowing light). An infrared camera should be handled with considerable care. The lens should be protected from scratches and should never be wiped or touched by hand to protect its sensitivity.

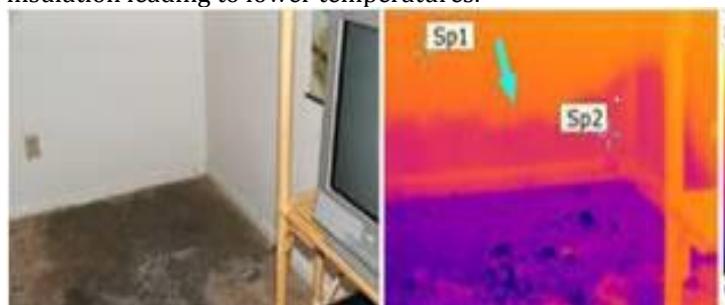
Fig 3.1.1:- Moisture penetration in a canopy

Figure 3.1.1 shows that Presence of moisture causes lower temperatures due to ambient evaporation, and consequent cooling of surfaces. Thermal images indicate the regions of temperatures distinguished by various colours or shades, depending upon the palette selected. Figure3.1.1 indicates the thermal image of a canopy. The image was taken late in the evening on a hot summer day in May of in mogara building garden city amravati. Most of the structure is at a high temperature of about 47C due to the absorption of solar radiation, but for two bands of about 43C on the soffit. On closer examination, it was found that the structure has a brick lining on the three free sides and rainwater stagnated along the two bands. Subsequently, dust an muck got deposited along a the bands, providing some degree of insulation leading to lower temperatures.

(a) Visual images (b) Thermal images

The dark regions underneath the windows in Figure3.1.1 indicate moisture penetration. The image was taken two days after brief showers in the summer month of May in mogara building garden city amravati. The rest of the wall is more or less of the same temperature of about 34C, while the dark regions are at temperatures lower than 31C, indicating the presence of moisture.
