# Critical Aspects of Condensate Polishers, Its Impact on Feed Water Quality & Potential Damage Mechanisms: Review

Nitin P. Karmarkar PhD

Senior Chemist, MSPGCL, Koradi Thermal Power Station Koradi, Nagpur-441111, India

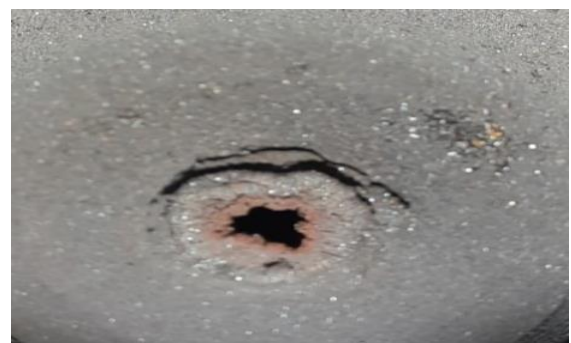
Crud can deposit on orifice over a time and slowly reduces the flow to the circuit tube. Fig 1. This may lead to improper flow distribution across water walls. The heavy accumulation of crud at the orifice opening may lead to starvation of water walls and may prone to overheating. Subsequently, leading to boiler tube failures. Since the primary site for the accumulation is at economiser, the frequent failures are occur in this zone may be of short term over heating type. Further, the deposition may occur in the form of layer on the water wall surfaces which cause inefficient transfer of heat to water through metal. That may also leads to boiler tube failures. In both the cases the type of failures can be identified. In first case, the melting or flow like pattern over the tube material can be observed. In second case fish mouth wide opening is observed due to overheating as shown in the Fig 2.

**Fig1. Orifice Choking due to Crud accumulation**

Ingress of turbidity due to crud may get deposited at orifice from where the water is being circulated to water wall. The orifices are designed to provide the equal flow distributions across the water wall.

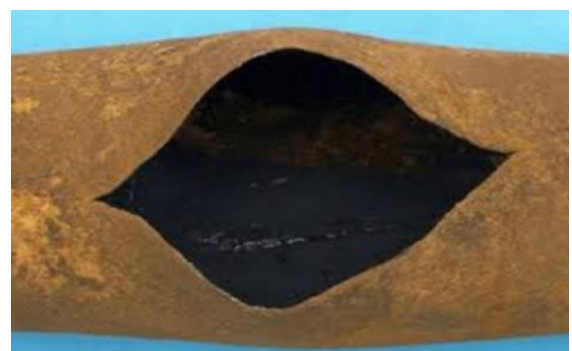
**Fig:2 Short Term Overheating of Boiler waterwall Tube due to overheating.**
