# TRIBOLOGICAL ASPECTS OF AGRICULTURAL EQUIPMENTS: A REVIEW

Parvinkal Singh Mann<sup>1</sup>, Navjeet Kaur Brar<sup>2</sup>,

<sup>1&2</sup> Assistant Professor, Department of Mechanical Engineering, Chandigarh University, Punjab, India-140413

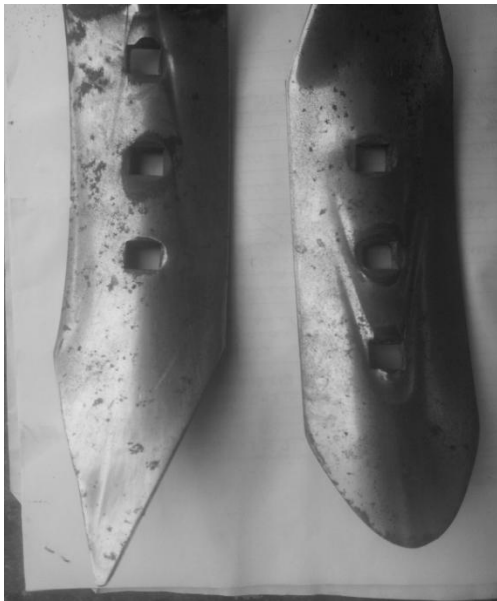
**Fig-2:** A new and a worn out ploughshare parts
